TRANSPORTATION RESEARCH CENTER

ON-SITE AIR BAG INVESTIGATION

CASE NO. - 96-15
FLEET - PRIVATE VEHICLE
LOCATION -
ACCIDENT DATE - 1996

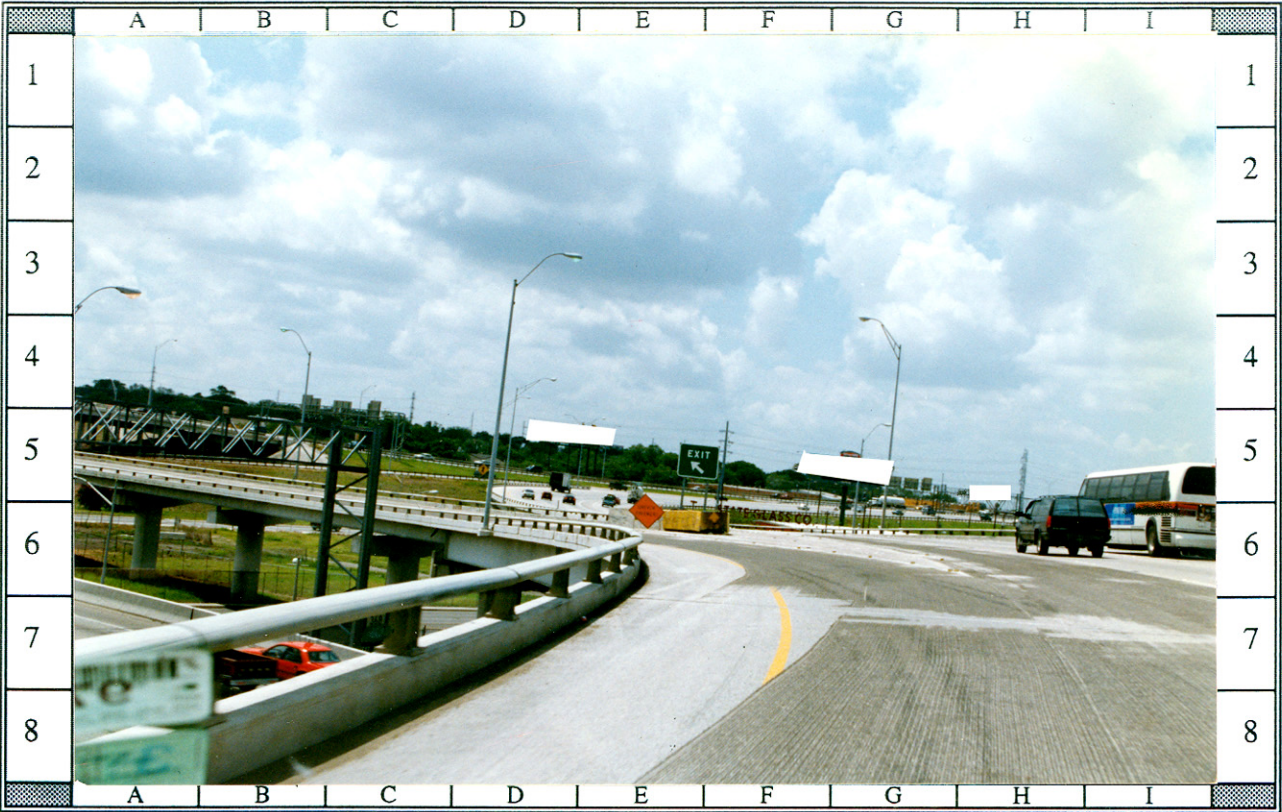
01: Case Vehicle’s curved southbound path of travel entering entrance ramp to east-bound interstate approximately 50 meters (164 feet) from initial impact

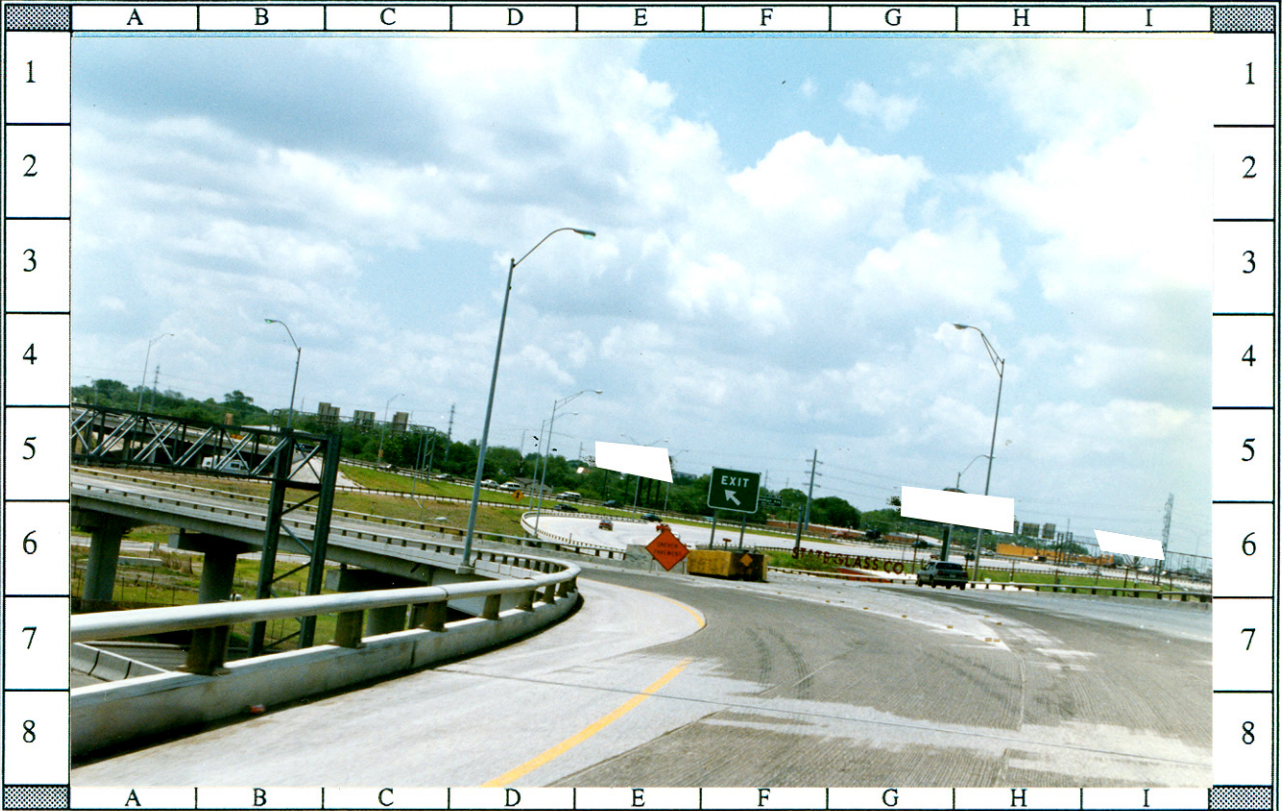
02: Case Vehicle’s curved southbound path of travel entering entrance ramp to east-bound interstate approximately 40 meters (131 feet) from initial impact

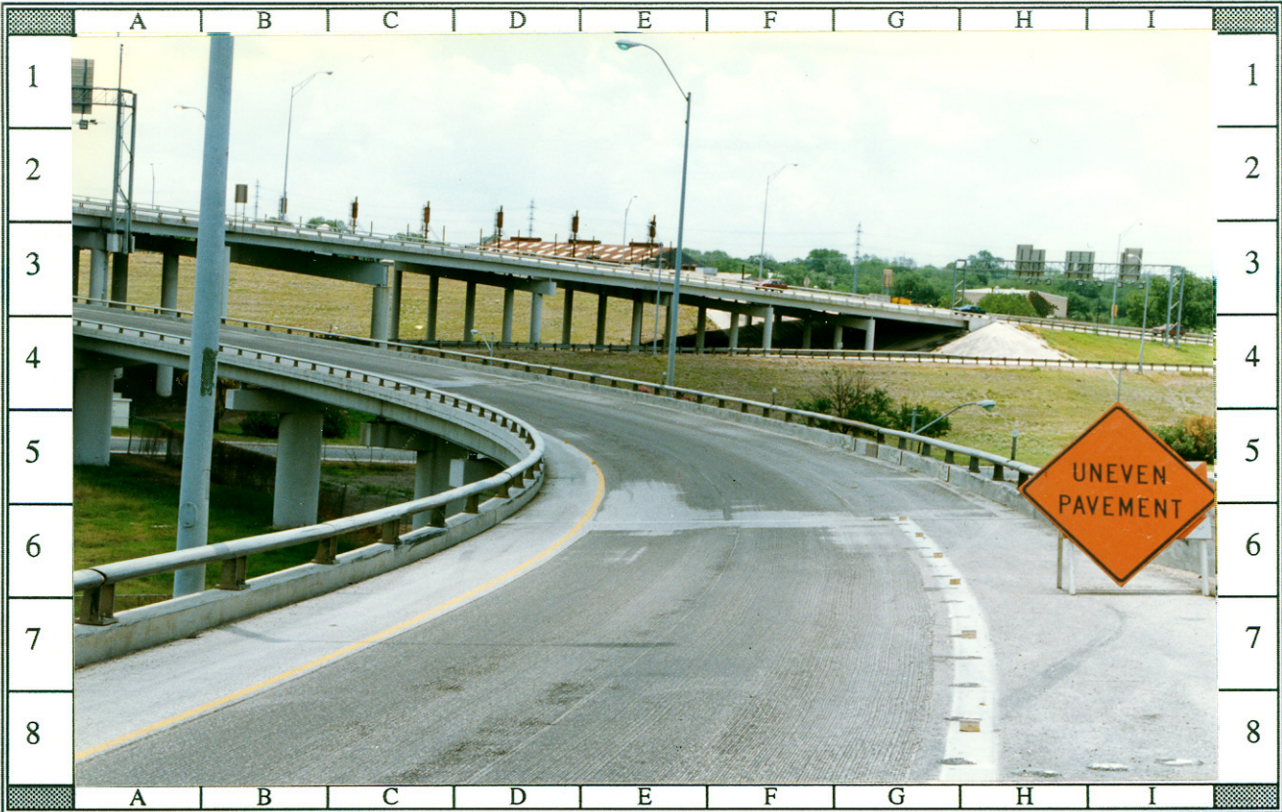
03: Case Vehicle's southeastward travel path in entrance ramp; NOTE: black scuffing (cell C6) from left front tire on left barrier indicates initial impact location

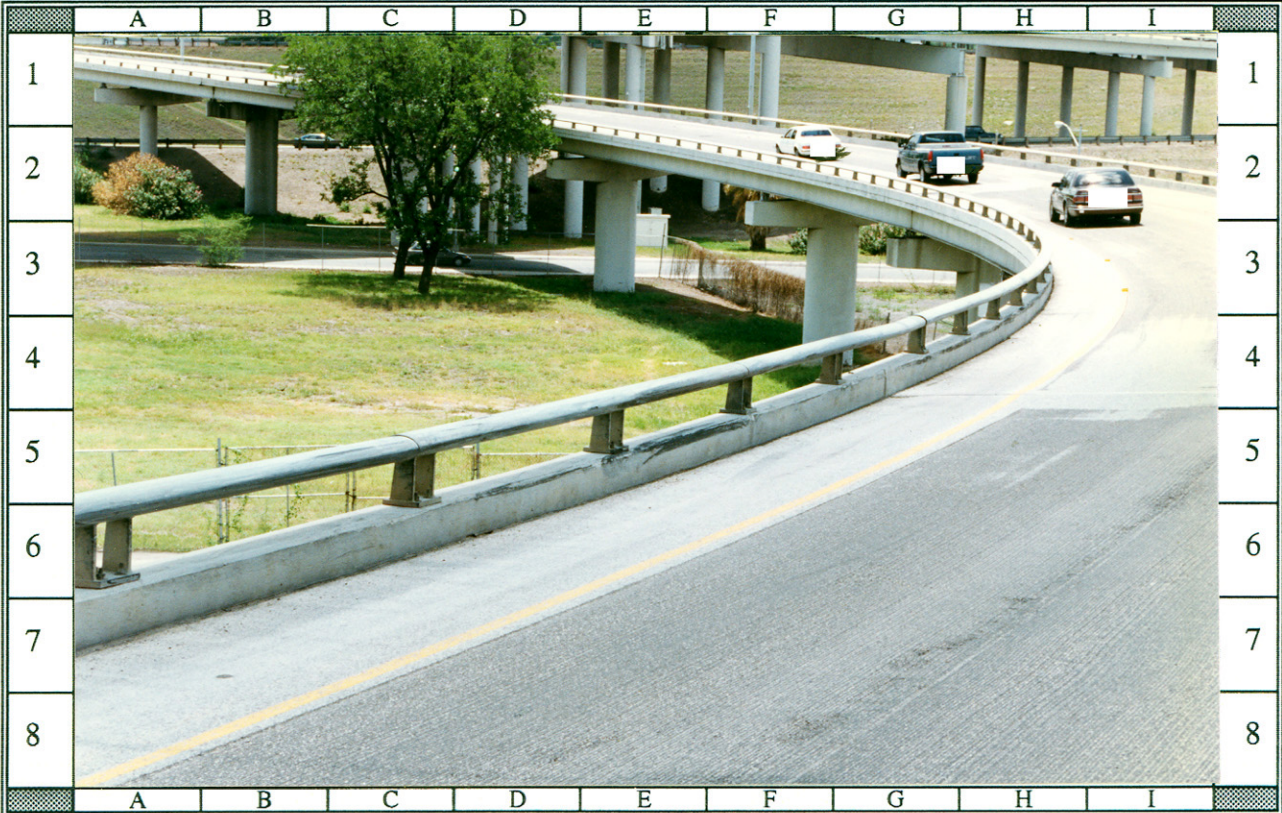
04: Eastward view of contact damage to left (North) longitudinal barrier from Case Vehicle's front left corner and left front tire (cells D5--E4)

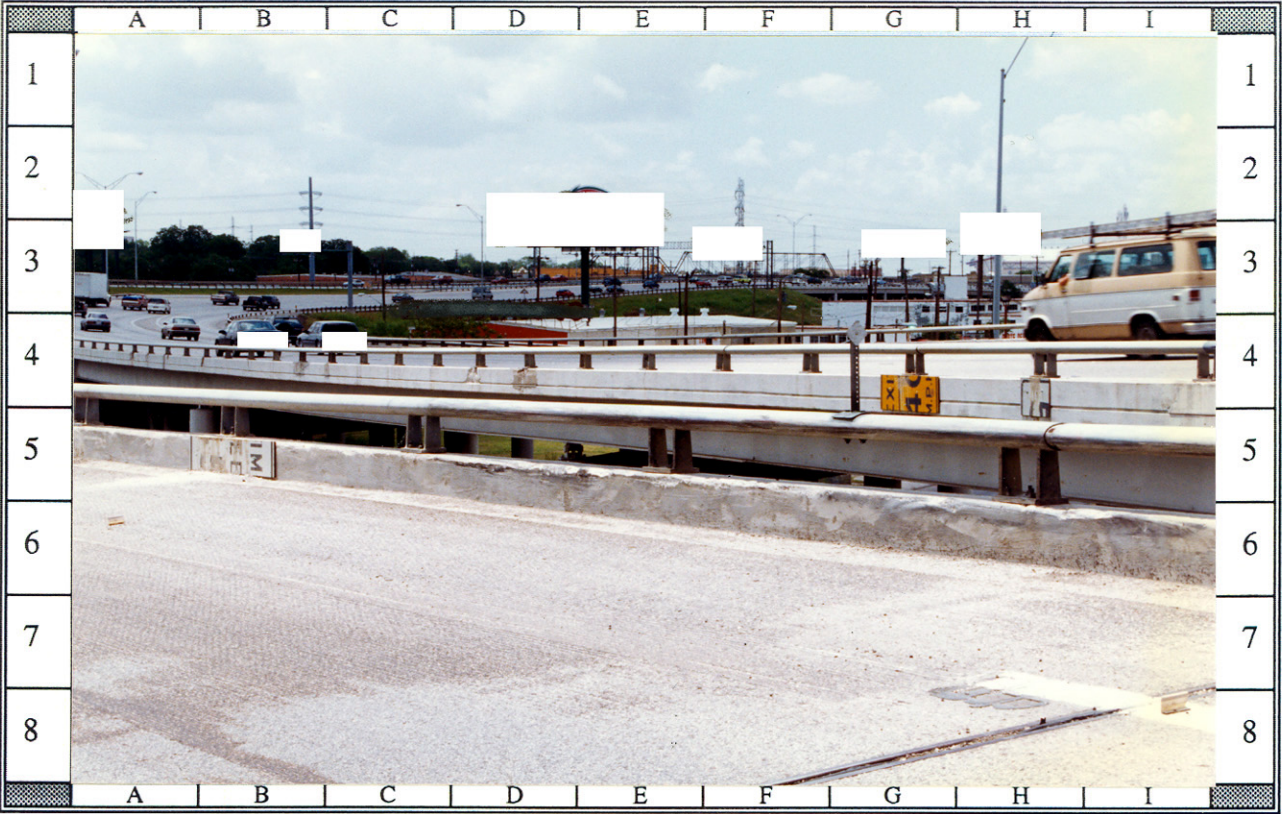
05: Southward view of contact damage to right (South) longitudinal barrier from Case Vehicle's front right corner and right front tire (cells D5--H6)

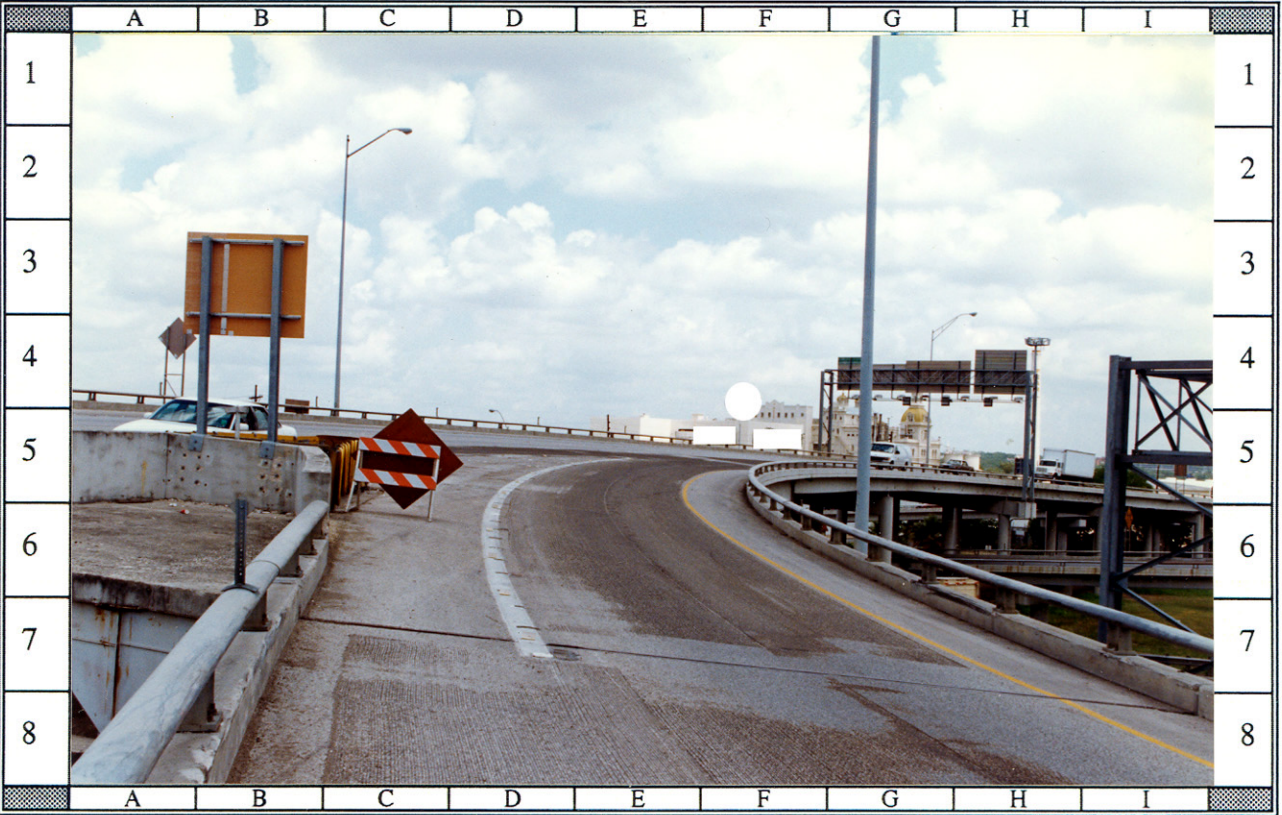
06: Northwestward view of Case Vehicle's southeastward travel path from area of final rest

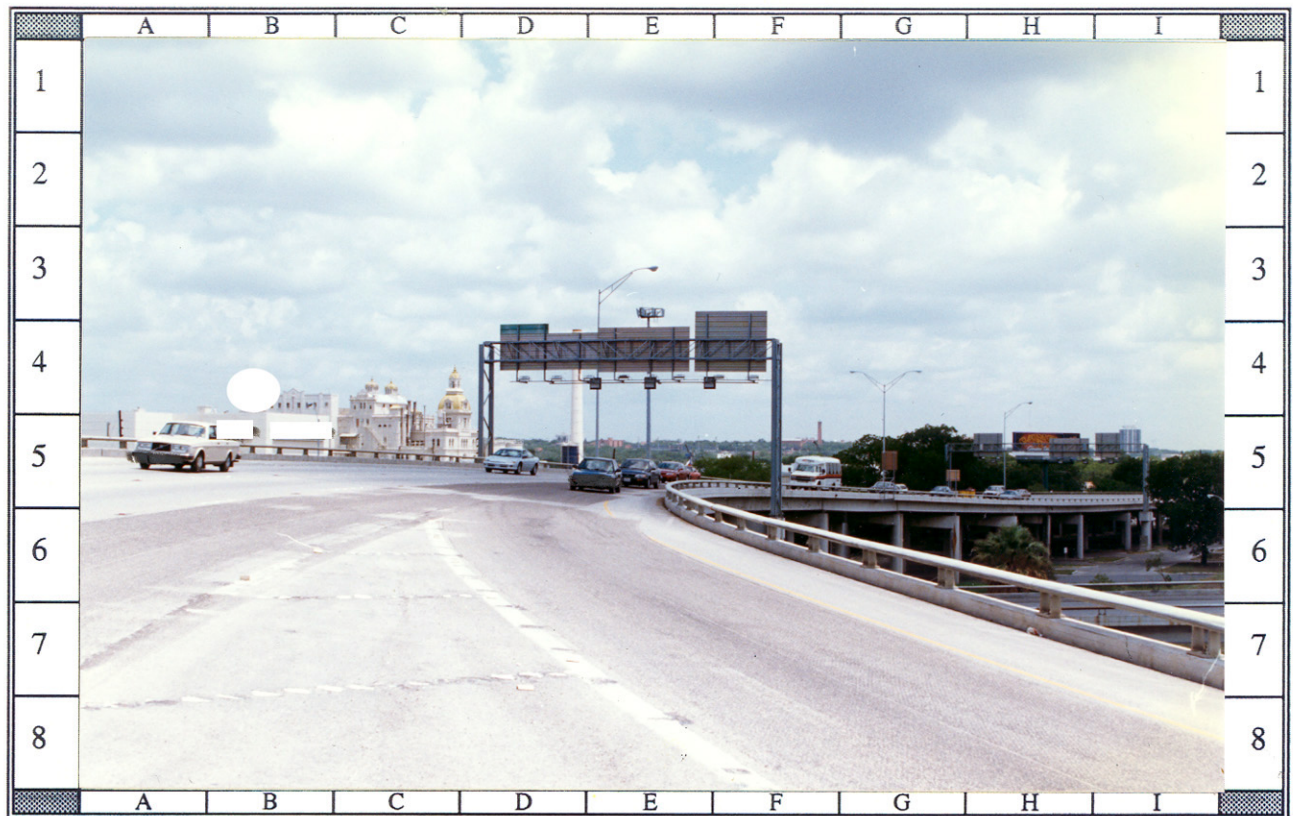
07: North-northwest view of Case Vehicle's southward travel path viewed from area across from Case Vehicle's initial barrier impact (i.e., at right side of photo)

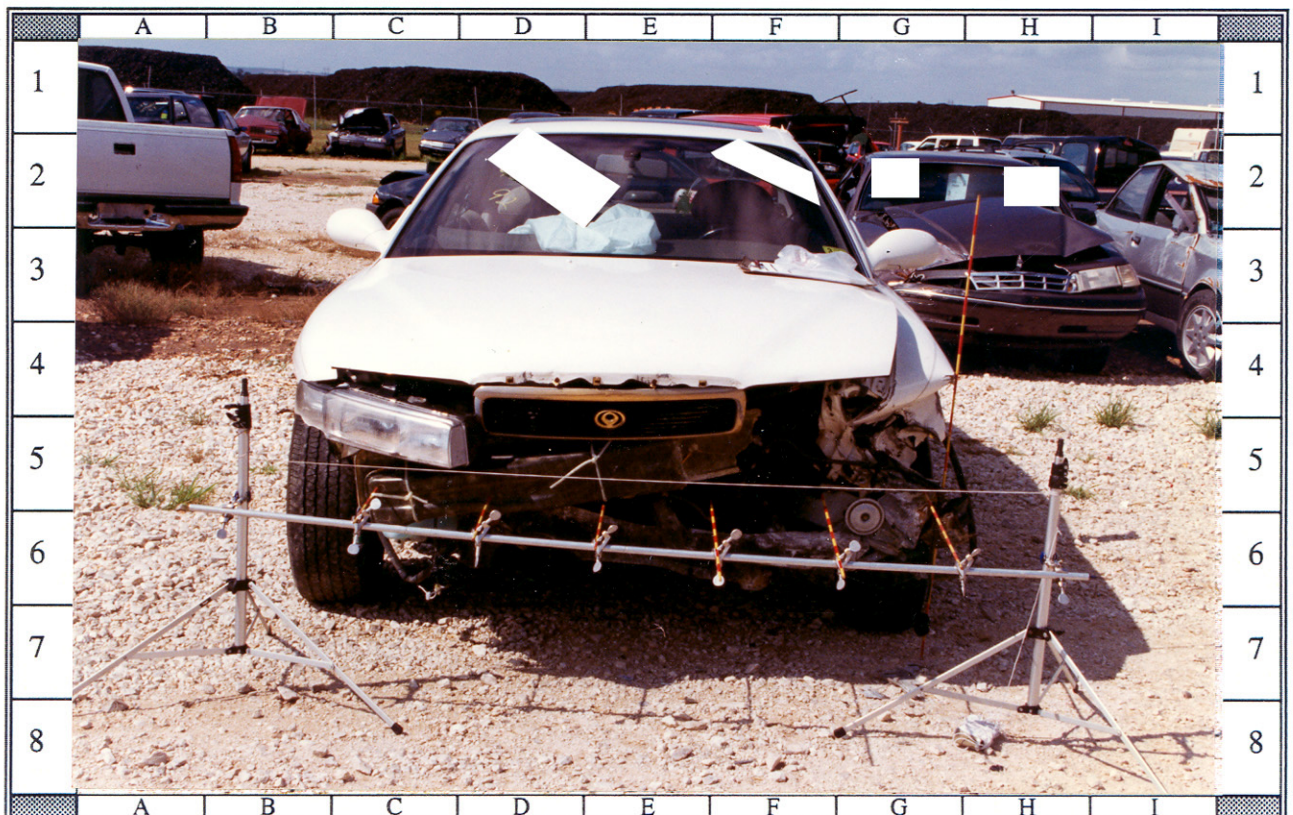
08: Case Vehicle's damaged front with contour gauge present; NOTE: bumper torn away and front left crush is more extensive than front right crush

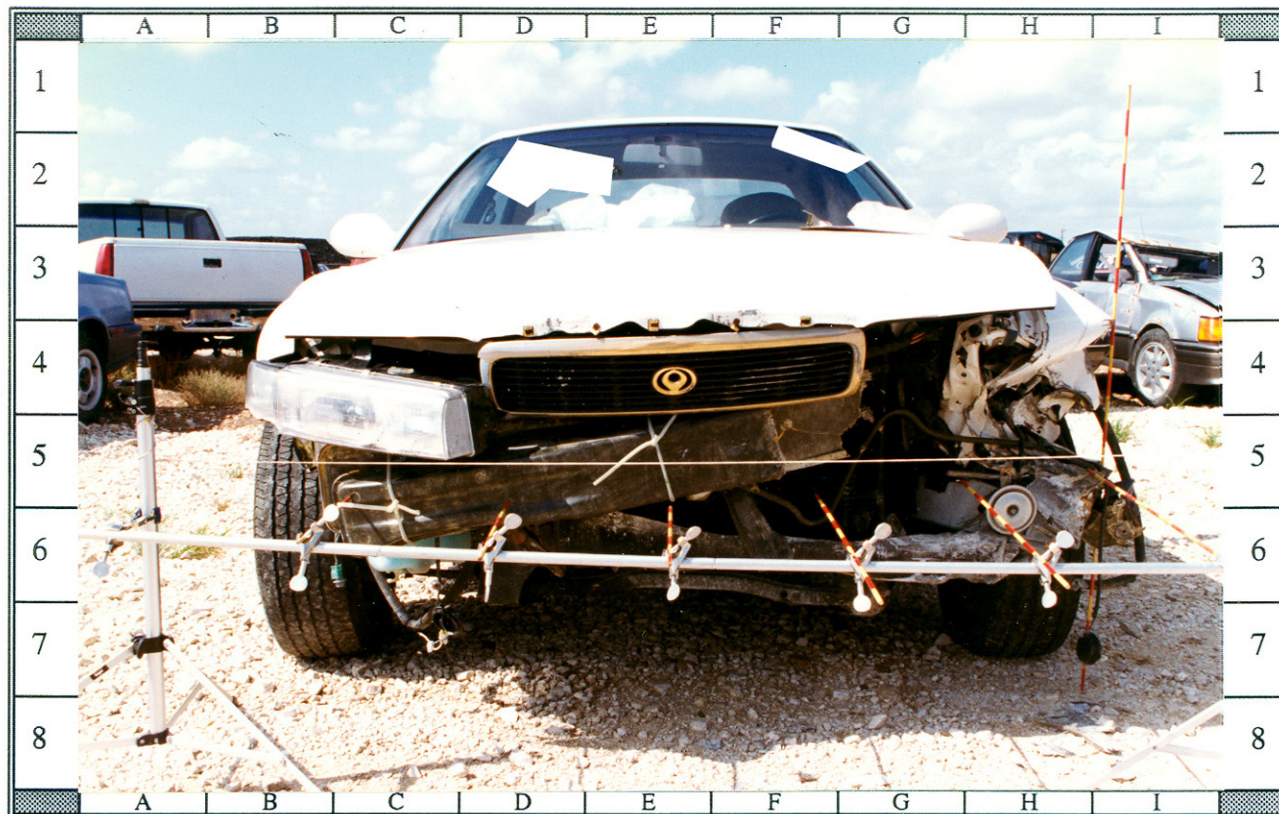
09: Close-up of Case Vehicle's frontal damage viewed at bumper level with contour gauge present; NOTE: bumper and left front headlight assembly are gone

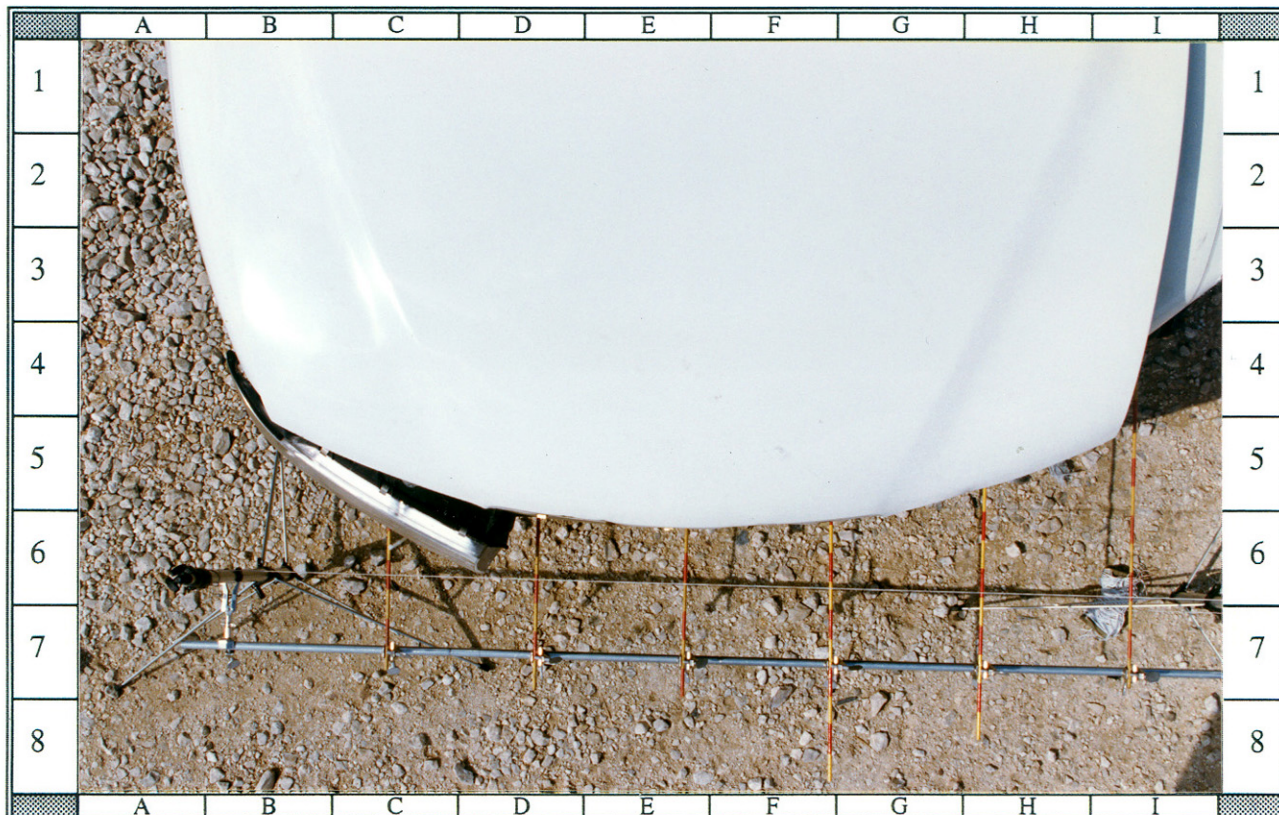
10: Overhead view of Case Vehicle's damaged front; NOTE: crush measurements extend underneath hood edge

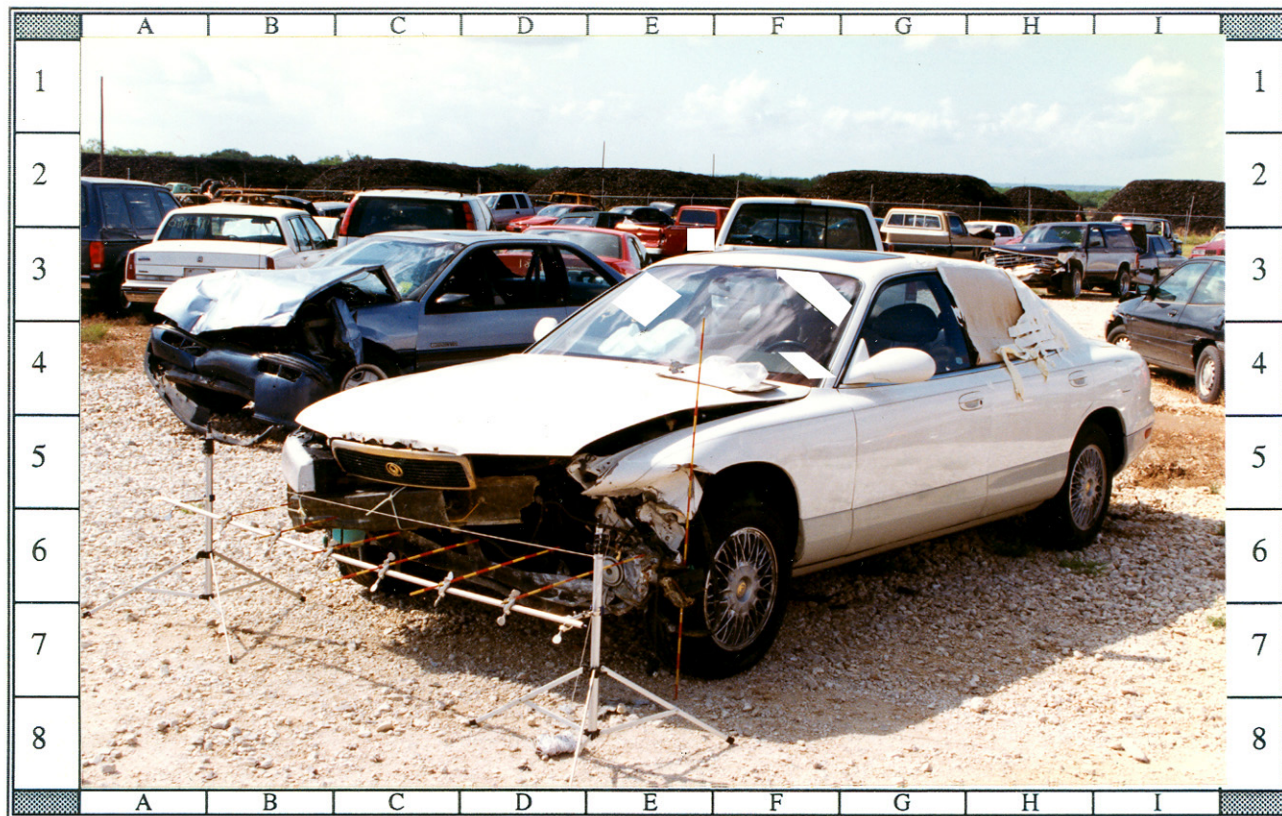
11: Case Vehicle's damaged front viewed from approximately 45 degrees left of front; NOTE: extensive crush penetration at left front corner

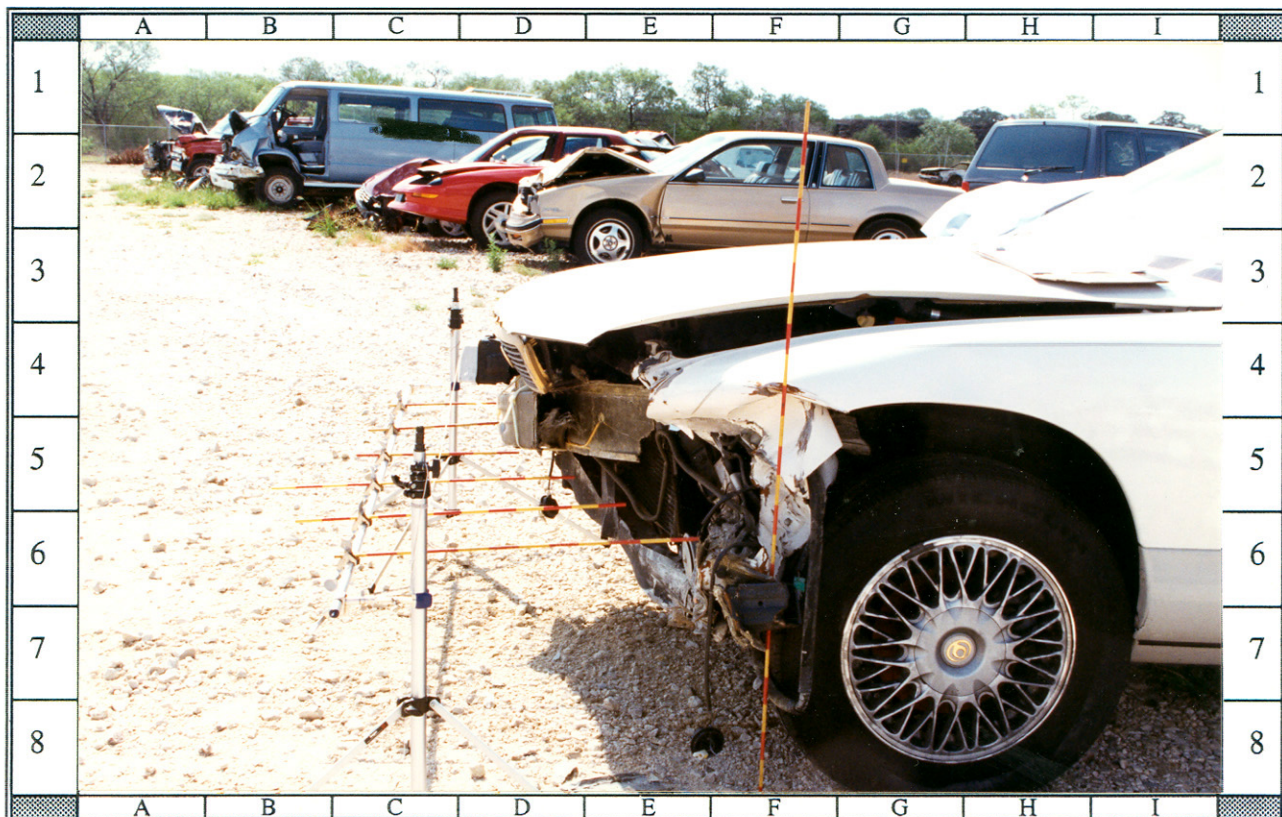
12: Reference line view of Case Vehicle's frontal damage from left; NOTE: crush penetration at frame is much more extensive to front left than to front right

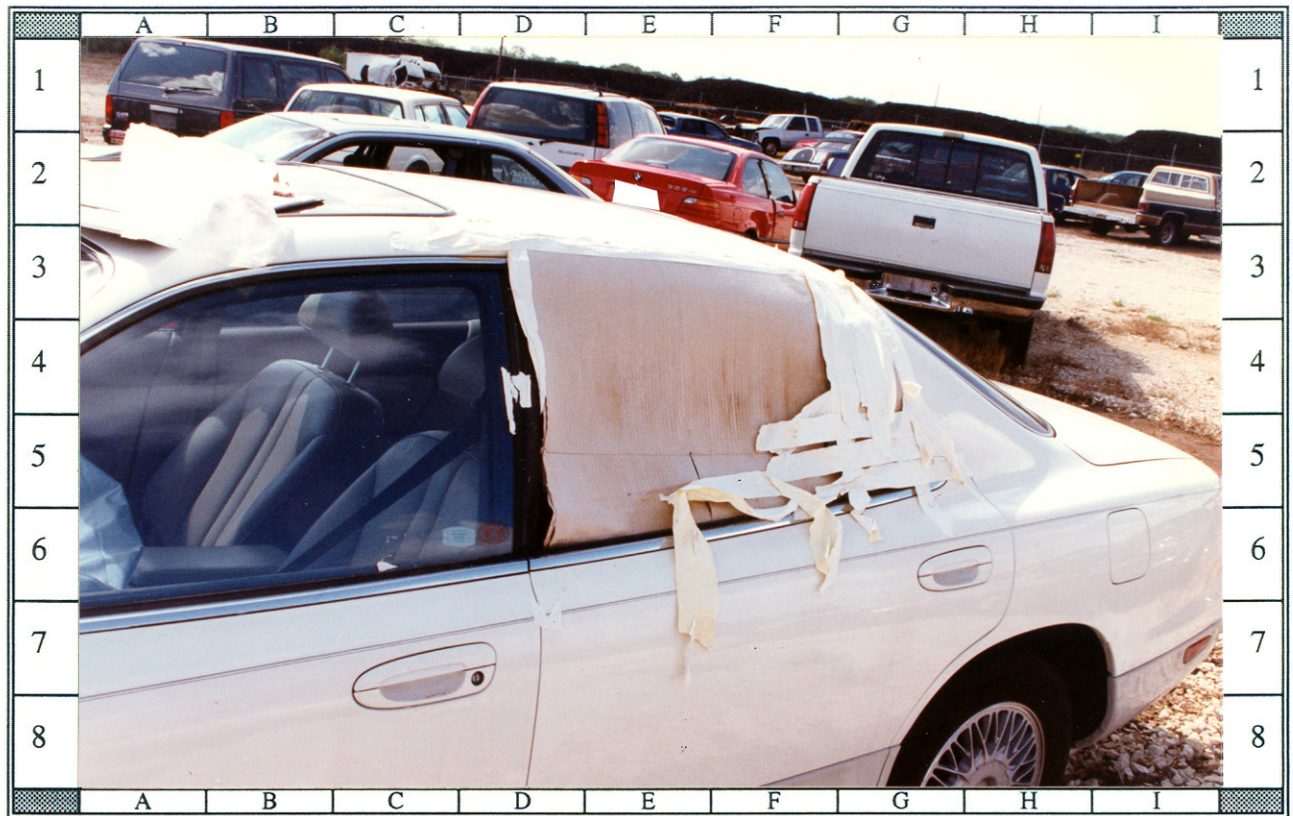
13: Case Vehicle's damaged left rear window viewed from approximately 15 degrees front of left; NOTE: window was shattered during the deployment of the air bags

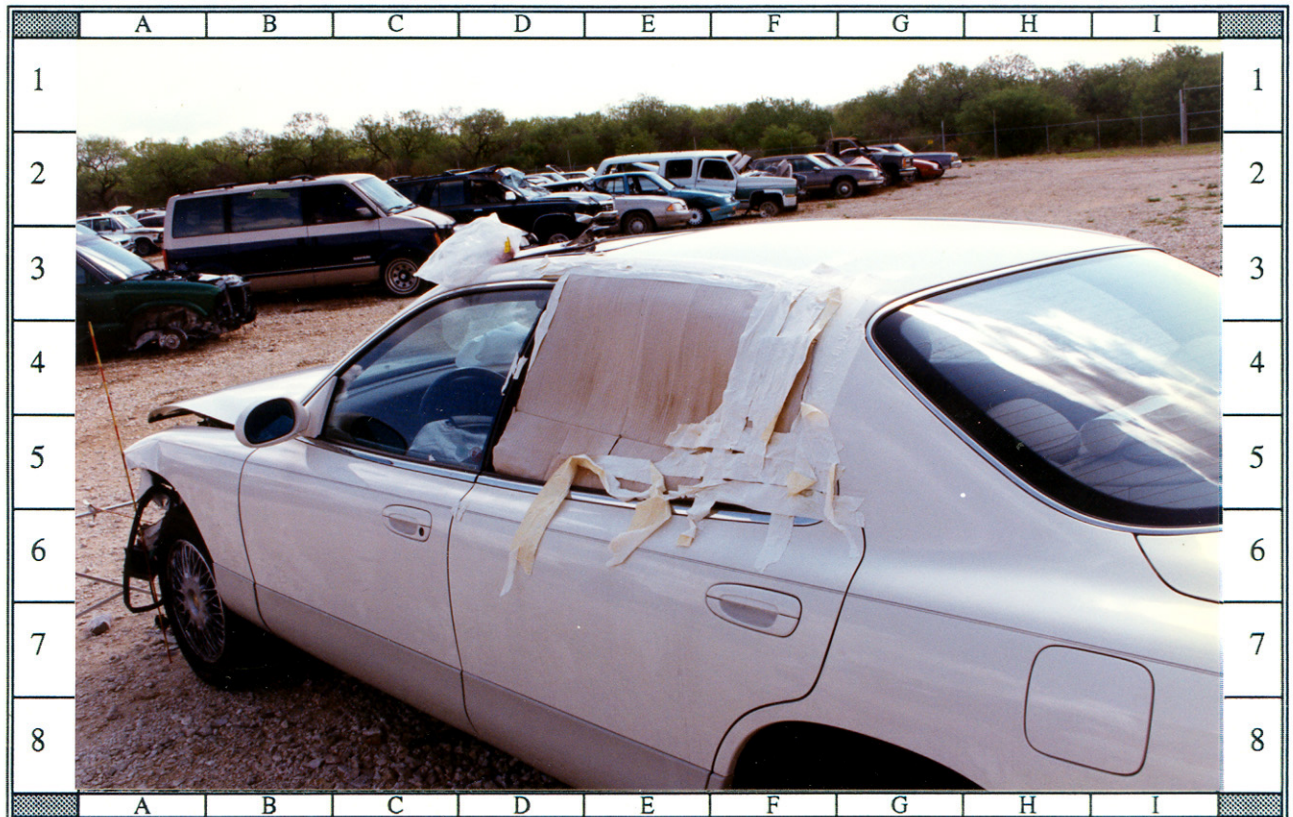
14: Case Vehicle's shattered left rear window viewed from approximately 30 degrees back of left; NOTE: undamaged left side rearward of left front wheel

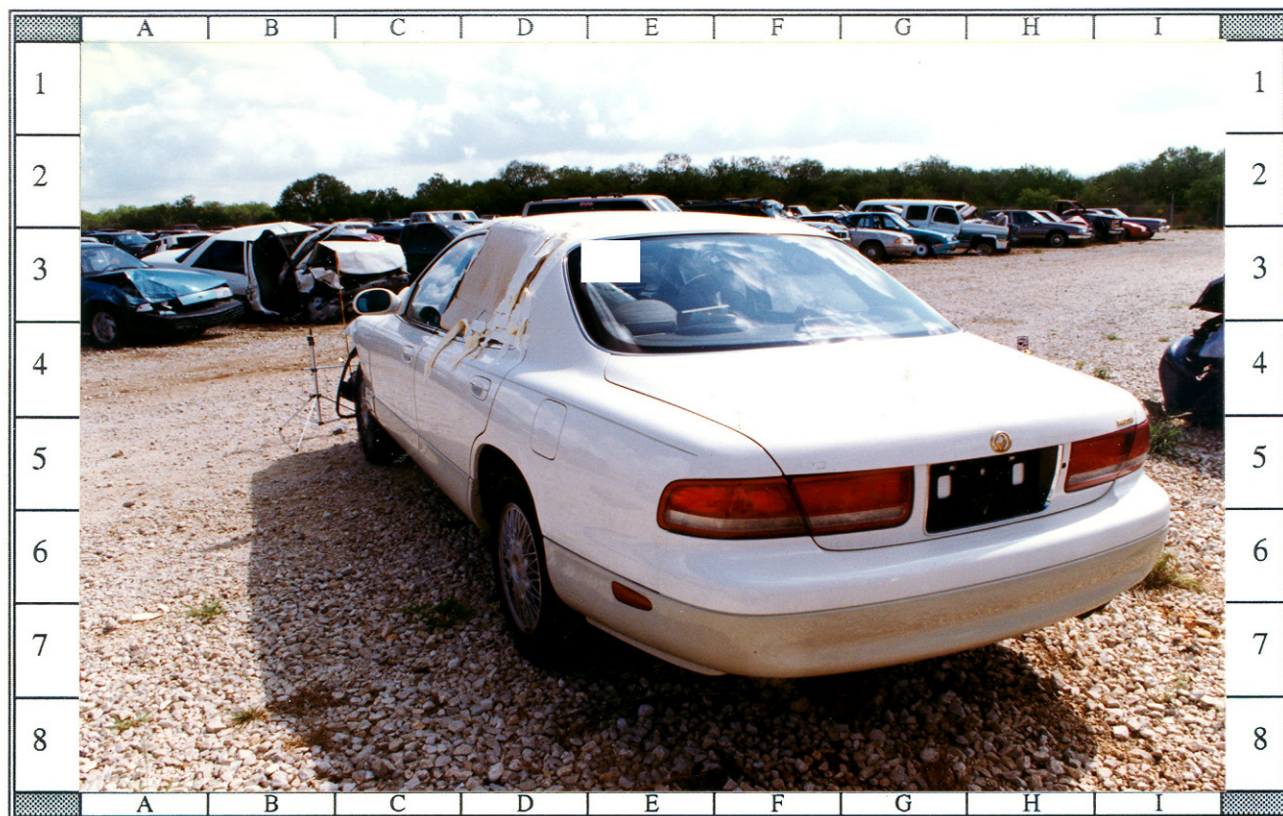
15: Case Vehicle's undamaged left side (behind left front wheel, except left rear window) and back viewed from approximately 30 degress left of back

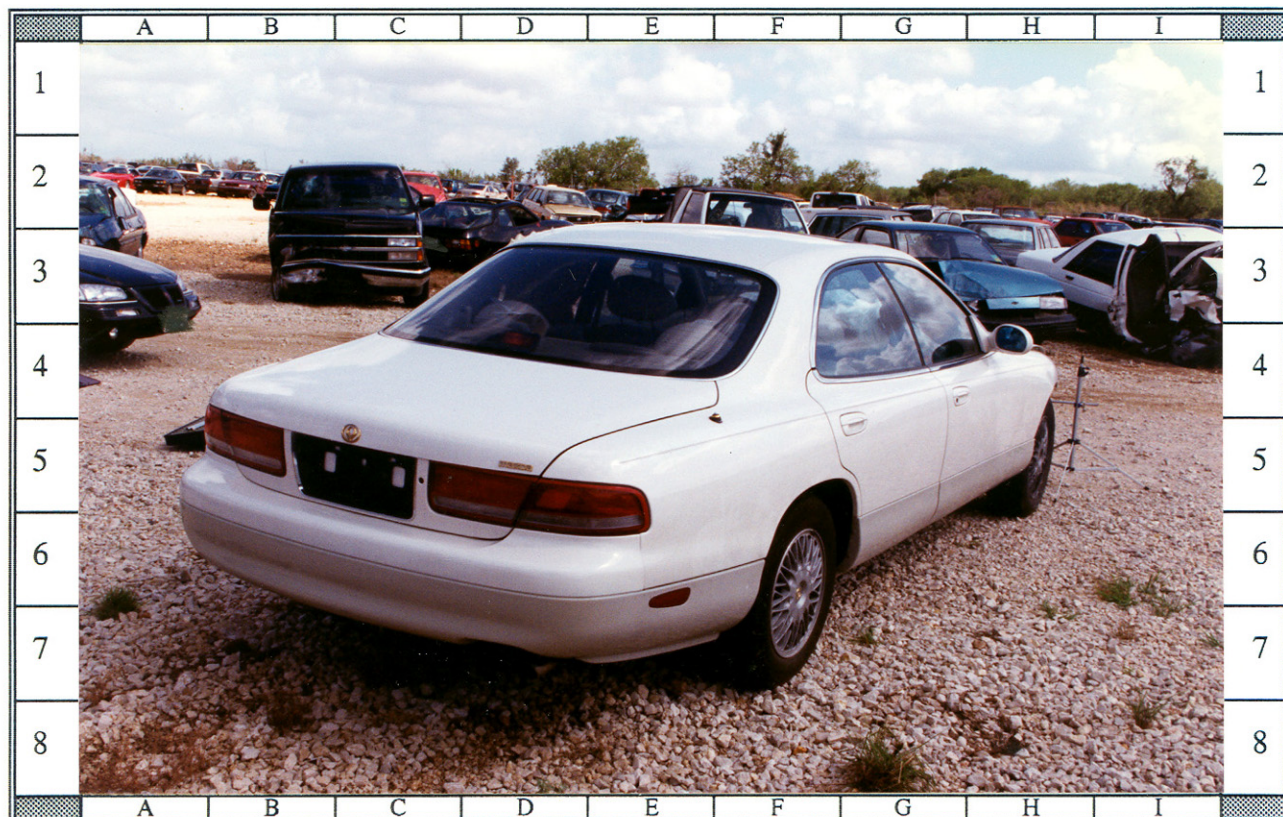
16: Case Vehicle's undamaged right side (i.e., behind right front wheel) and back viewed from approximately 30 degrees right of back

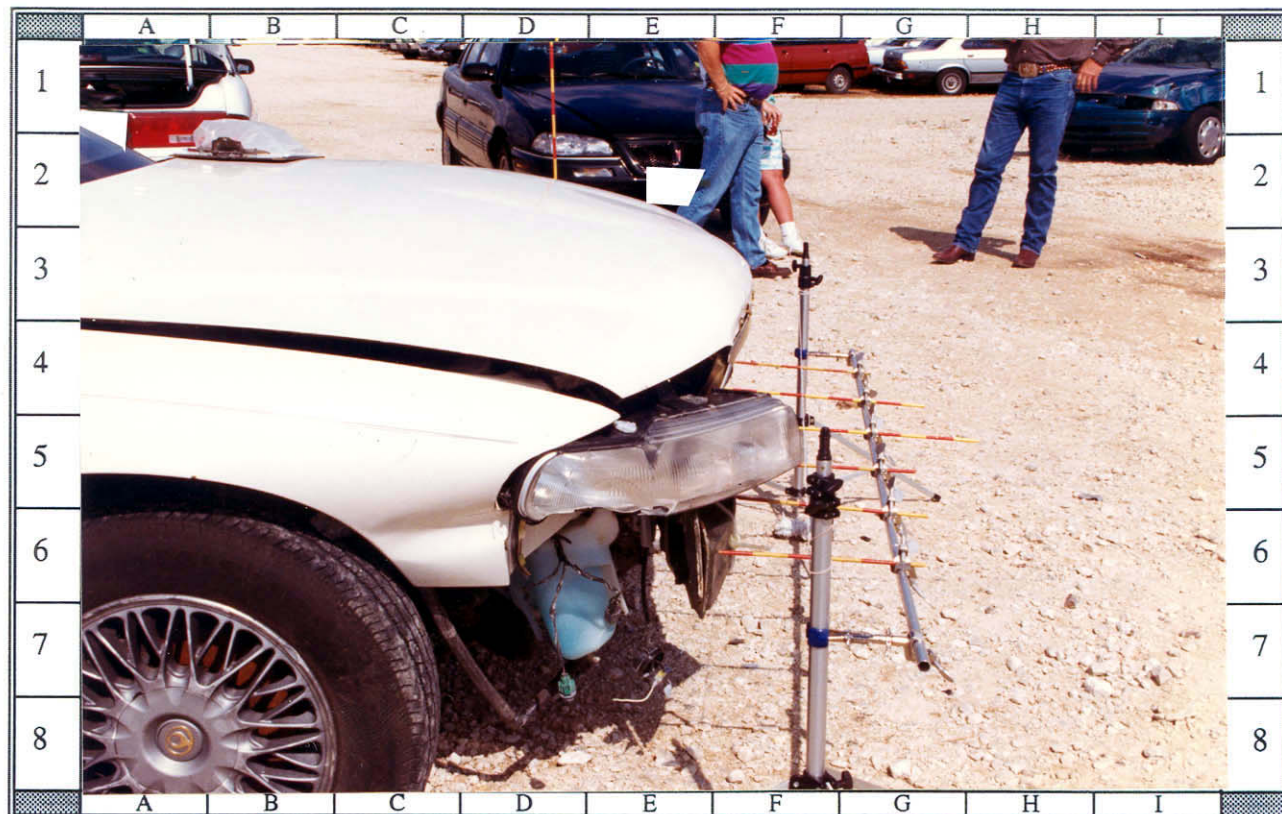
17: Reference line view of Case Vehicle's frontal damage from right; NOTE: direct damage to right front corner and fender from second longitudinal barrier impact

impact by continuing to brake and steering back to her left. This maneuver would explain the damage to the case vehicle's front right corner and right front fender.

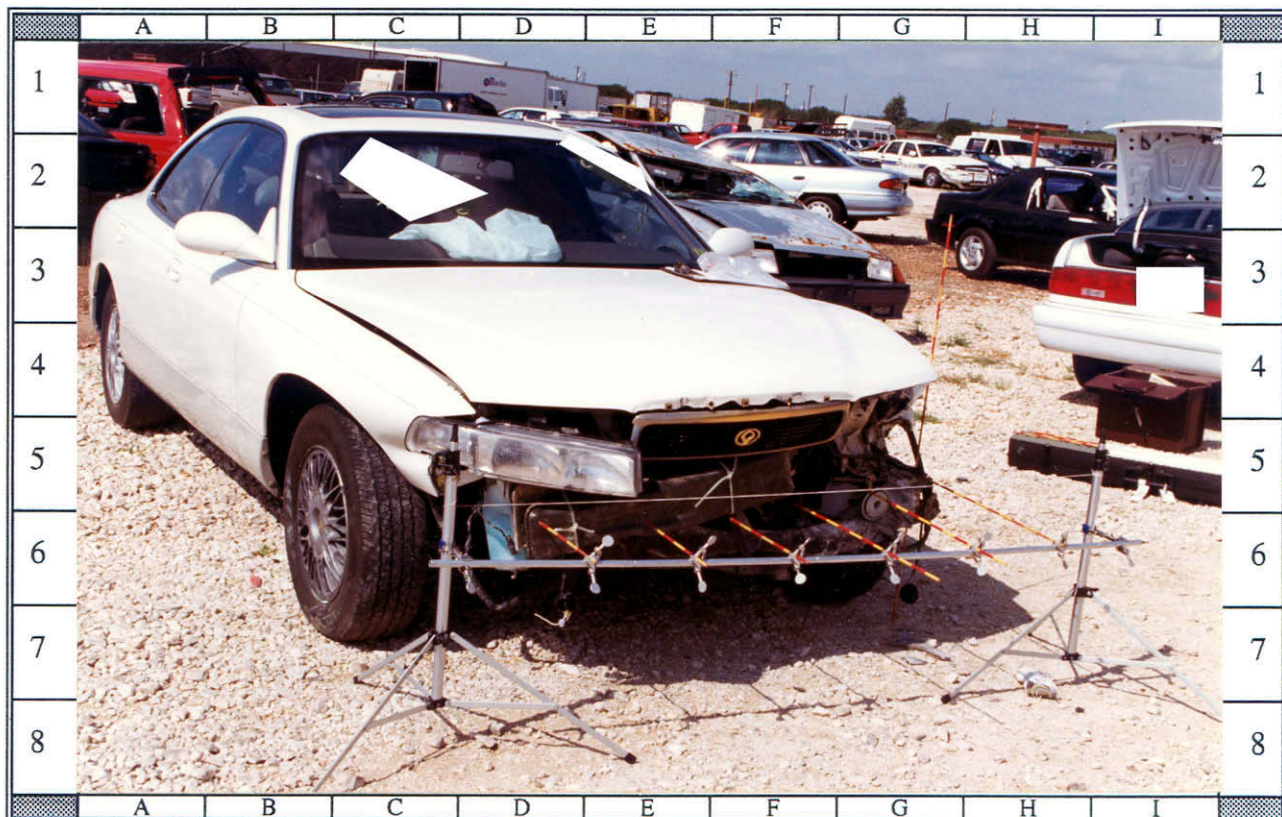
18: Case Vehicle's damaged front viewed from approximately 30 degrees right of front; NOTE: front left crush is more extensive than front right crush

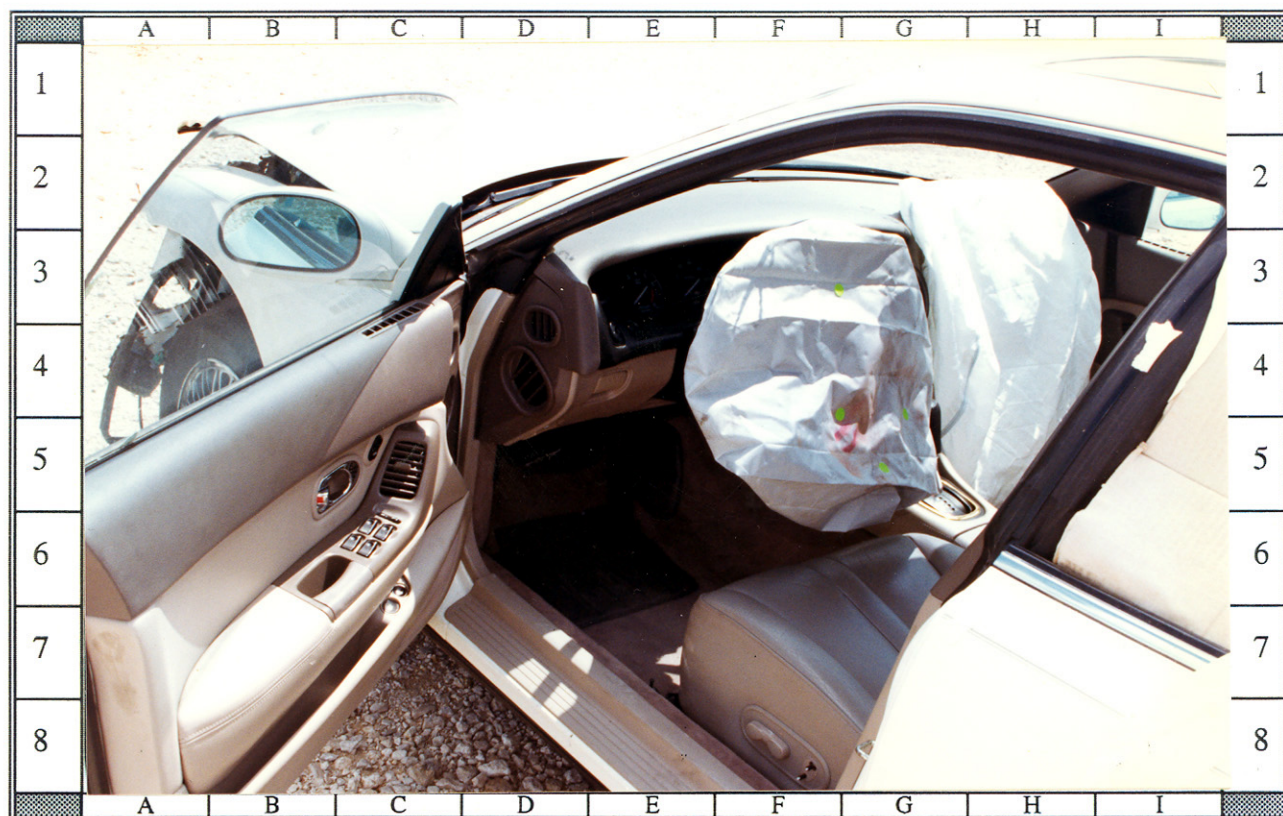
19: Interior surface of Case Vehicle's driver door, driver's seating area, and deployed air bags; NOTE: contact evidence to driver's air bag

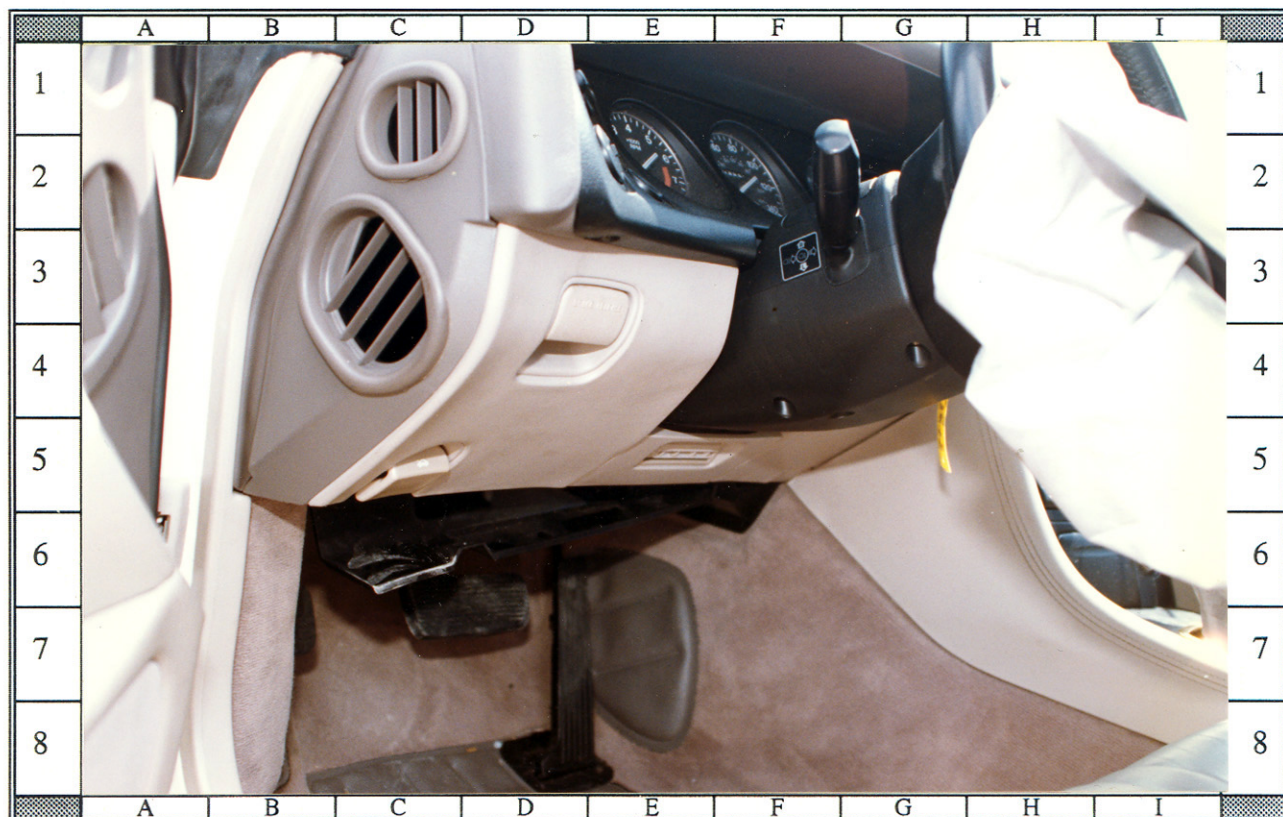
20: Case Vehicle's driver seating area showing noncontacted instrument panel, knee bolster, and lower steering column

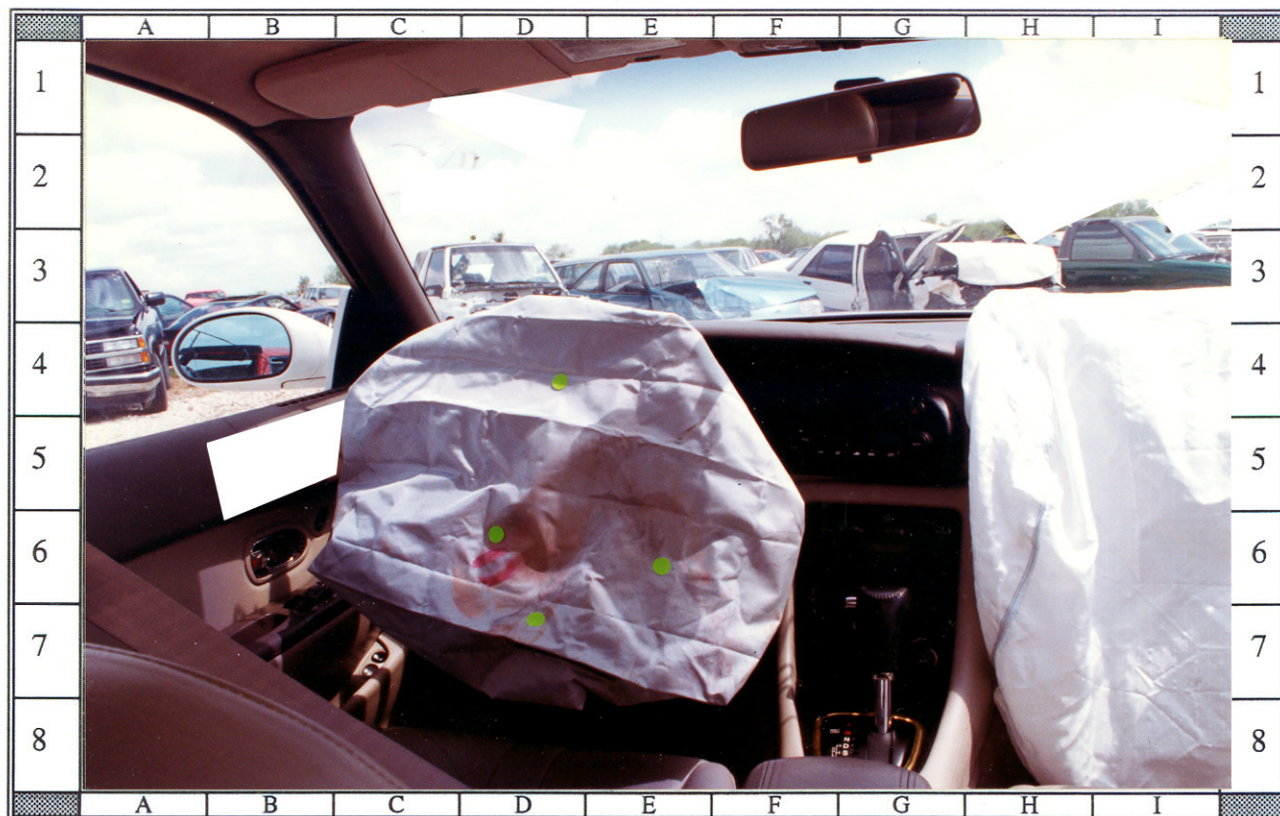
21: Panoramic view of Case Vehicle's greenhouse area showing deployed air bags and undamaged glazing; NOTE: multiple contacts to driver's side air bag
